<i>Issue Date</i>	<i>Org. Code</i>	NATIONAL WEATHER SERVICE	<i>Program</i>	<i>Part</i>	<i>Section</i>
	W/OSO321	Engineering Handbook	EHB-11	02	3.6

MODIFICATION INDEX - AUTOMATED SURFACE OBSERVING SYSTEM

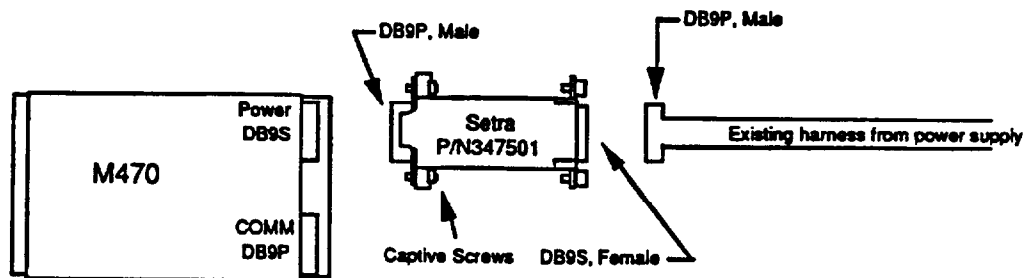
External Threshold Detector for Setra Model 470

This adapter module is installed in series between the Setra Model 470 and a 5 vdc regulated power supply.

1. Unplug the existing power supply harness from the M470 power connector.
2. Plug the 347501 module into the 470 power connector.
3. Tighten the captive screws on the module into the screw jacks on the M470.
4. Plug the existing power supply harness into the 347501 module.

This module contains a circuit which monitors the voltage level of the power supply. In the event of an under-voltage condition, this circuit shuts off the voltage supply to the 470 and does not turn it back on until the supply exceeds the threshold voltage, in order to ensure proper reset and startup.

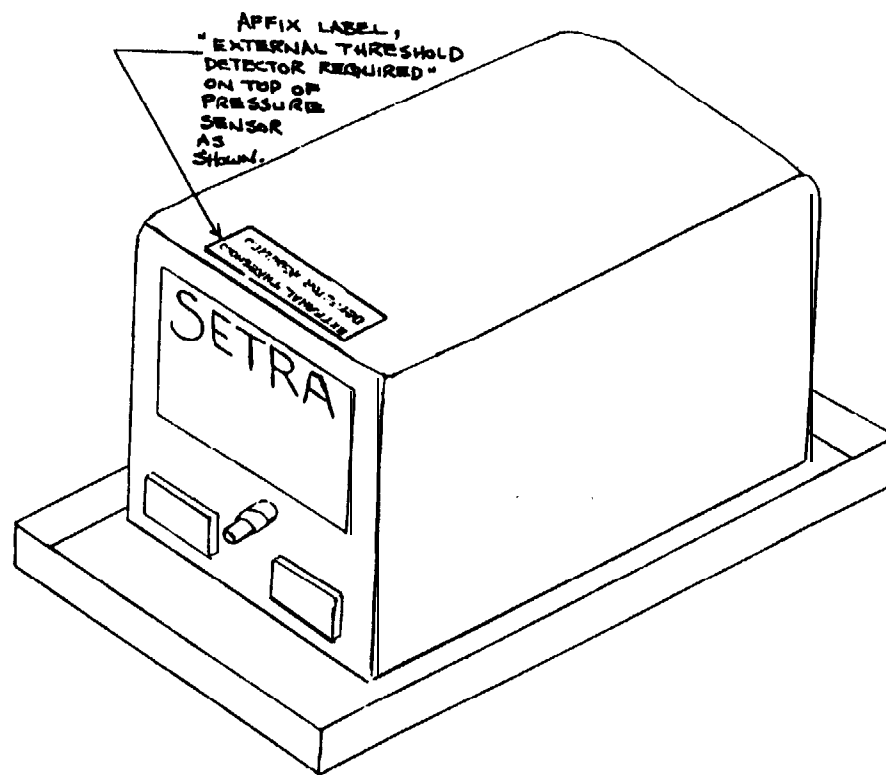
F i g u r e 1

1. At the ACU RF/Pressure tray, locate the 4-port pressure tubing coupler and cut the ty-strap securing it in place.
2. Relocate holes for tubing coupler. Refer to ECN 19316 (sheet 2) for hole size and location. Restrap the coupler in the new position.
3. Install the Setra external threshold detector (part number 347501) per Setra installation instructions.
4. Secure RF/Pressure tray in the ACU cabinet and verify sensor is operational. (The sensor will resume reporting within 10 minutes.)
5. Affix label "EXTERNAL THRESHOLD DETECTOR REQUIRED" per Figure 1.

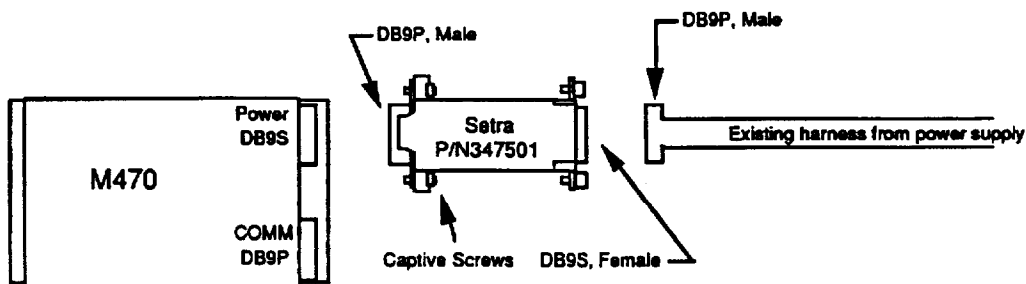
External Threshold Detector for Setra Model 470

This adapter module is installed in series between the Setra Model 470 and a 5 vdc regulated power supply.

1. Unplug the existing power supply harness from the M470 power connector.
2. Plug the 347501 module into the 470 power connector.
3. Tighten the captive screws on the module into the screw jacks on the M470.
4. Plug the existing power supply harness into the 347501 module.

This module contains a circuit which monitors the voltage level of the power supply. In the event of an under-voltage condition, this circuit shuts off the voltage supply to the 470 and does not turn it back on until the supply exceeds the threshold voltage, in order to ensure proper reset and startup.

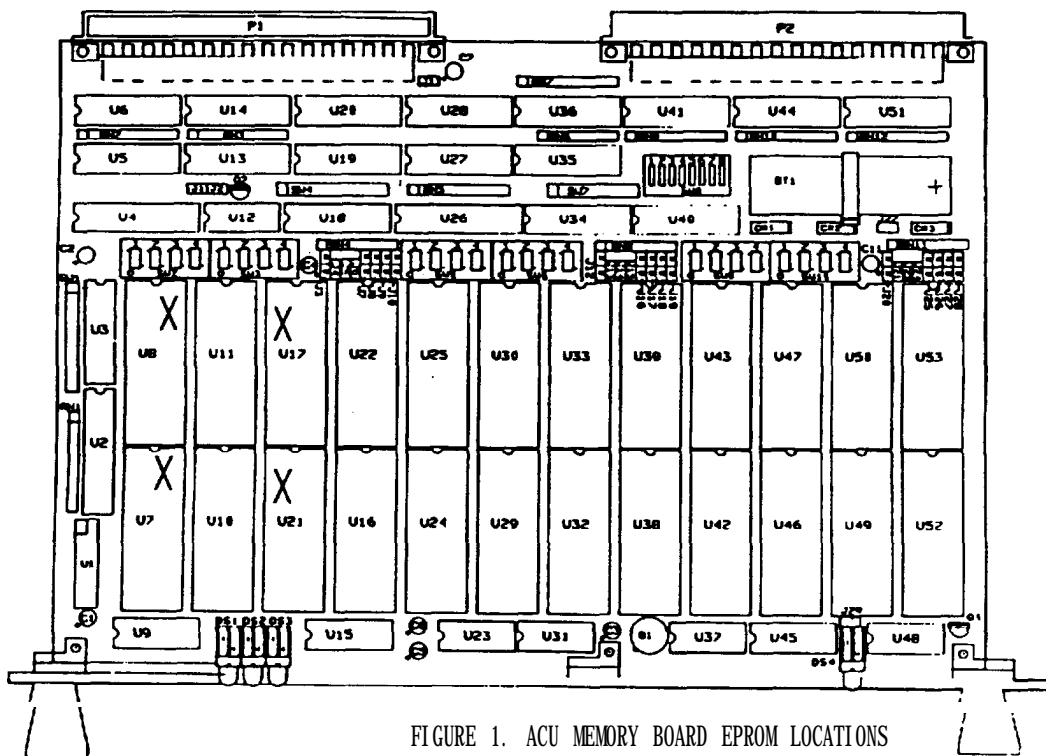
FIGURE 1. ACU MEMORY BOARD EPROM LOCATIONS

EPROM DESIGNATOR	PART NUMBER	FUNCTION
U6	62828-45002-1	BYTE 0
U17	62828-45003-1	BYTE 1
U7	62828-45004-1	BYTE 2
U21	62828-45005-1	BYTE 3

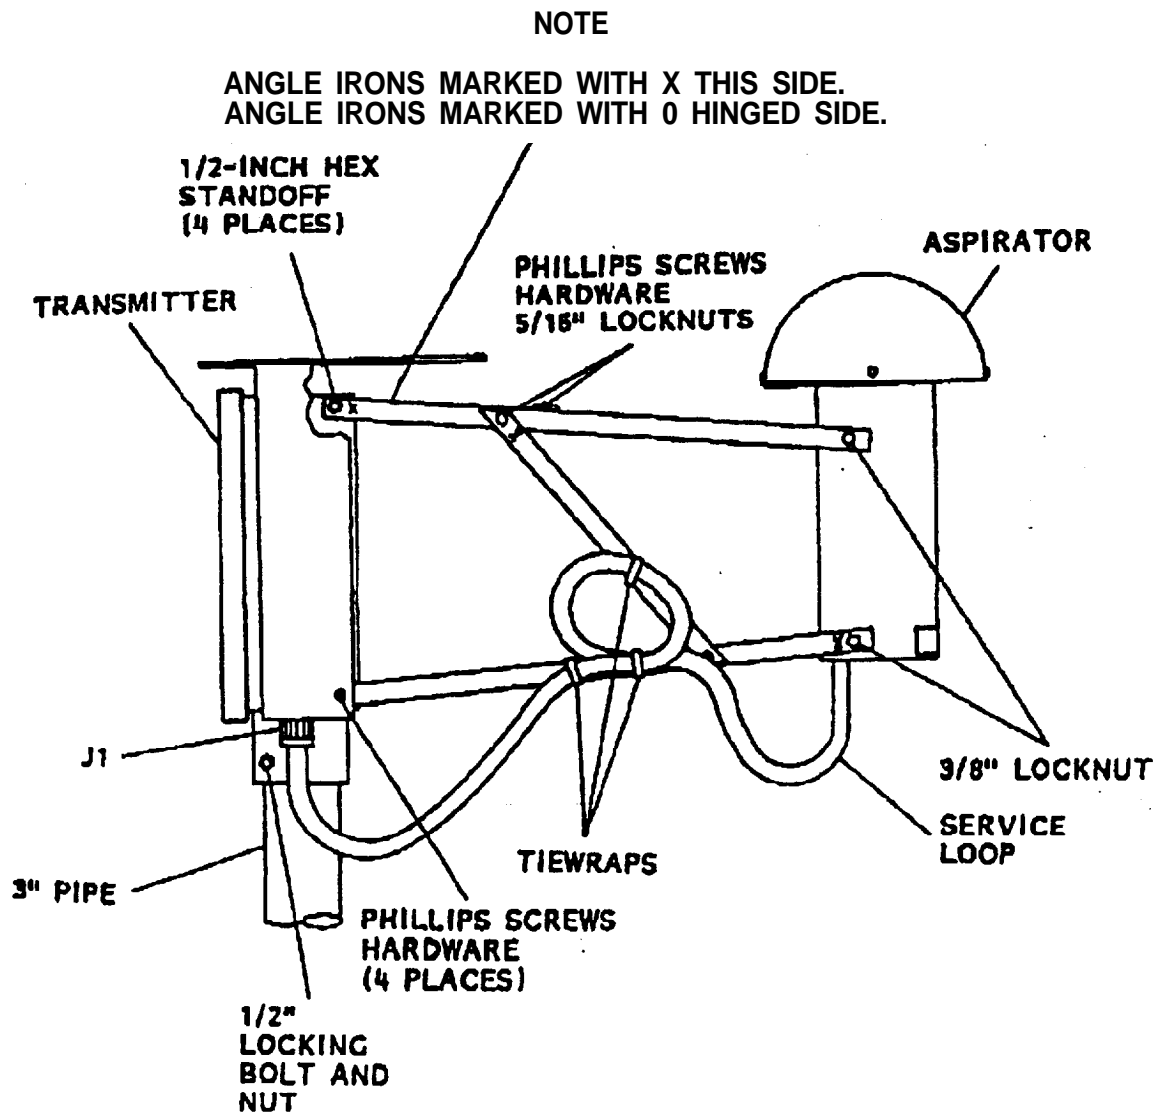
Figure 5.2.1, Temperature/Dewpoint Sensor Installation Diagram

10. Position the solar shield over transmitter with longest side facing aspirator (fig 5.2.1).
11. Using No. 2 Phillips screwdriver, install four screws, lockwashers, and flat washers securing solar shield to standoffs on transmitter.

12. Using cable tie wraps, secure aspirator cable to support arm assembly as shown on figure 5.2.1. Be sure to leave service loop to allow removal of dewpoint sensor fan without cutting tywraps.

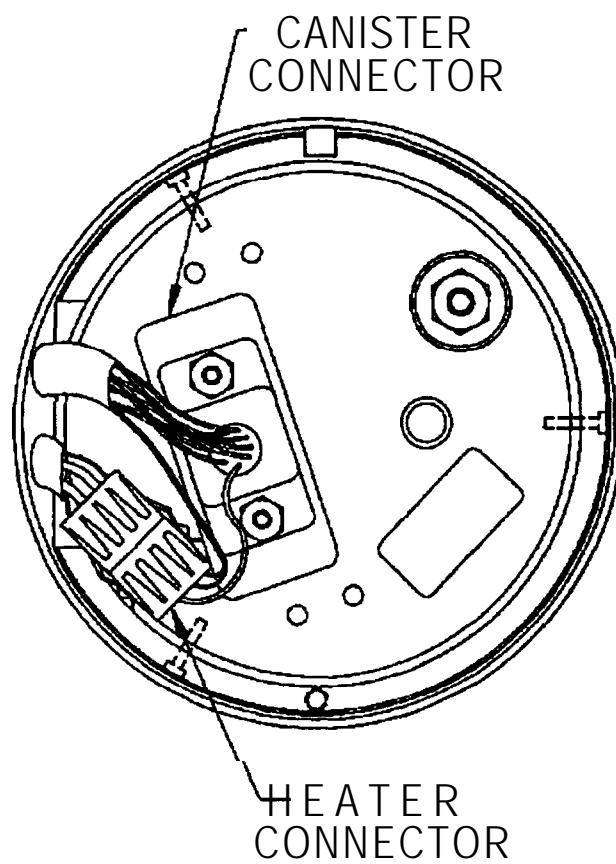
FIGURE 4

RECEIVER & TRANSMITTER CANISTER, END VIEW

- 5.2 Using small flat-tipped screwdriver, slide locking mechanism (plate at front of connector) downward to unlock DB-9 connector. **DO NOT** disconnect the DB-9 connector at this time. See attached drawing of canister end view for connector location, Figure 4.

- 5.3 Repeat steps 5.1 and 5.2 for the receiver assembly.
- 5.4 At the PC, type "V3". The sensor will enter the "Heater Calibration" mode. Follow the instructions displayed on the PC screen. The "Heater Calibration" mode can be aborted at any time by striking the <ESC> key. See attached drawing of canister end view for connector location, Figure 4.

- 4.3 Unlatch two fasteners and carefully remove transmitter assembly cap from the back of transmitter assembly.
- 4.4 Using small flat-tipped screwdriver, slide locking mechanism (plate at front of connector) downward to unlock DB-9 connector. DO NOT disconnect the DB-9 connector at this time. See attached drawing of canister end view for connector location, Figure 4.

- 5.1 Disconnect the DMM and remove jumper from J7.
- 5.2 At the PC, type "V3". The sensor will enter the "Heater Calibration" mode. Follow the instructions displayed on the PC screen. The "Heater Calibration" mode can be aborted at any time by striking the <ESC> key. See attached drawing of canister end view for connector location, Figure 4.

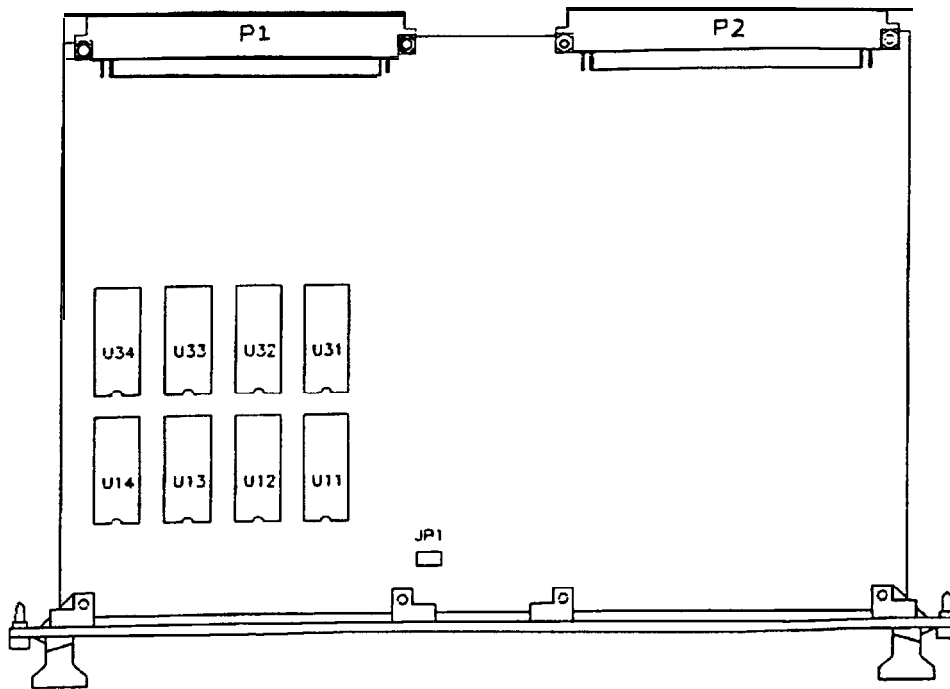
FIGURE 1

VOICE PROCESSOR BOARD 1A2A20

ASSY 62828-47018-10

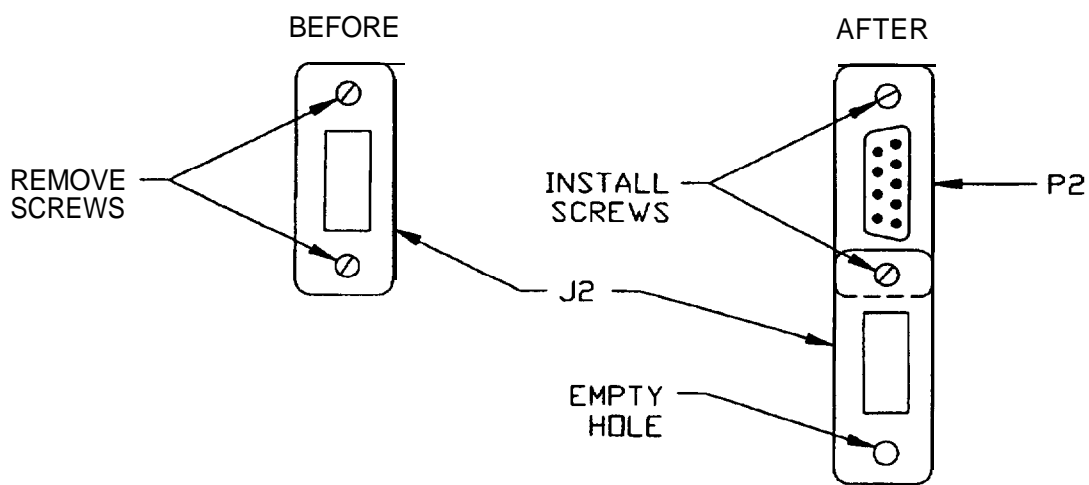
FIGURE 1.

AUTO BALANCE MODULE CONNECTOR

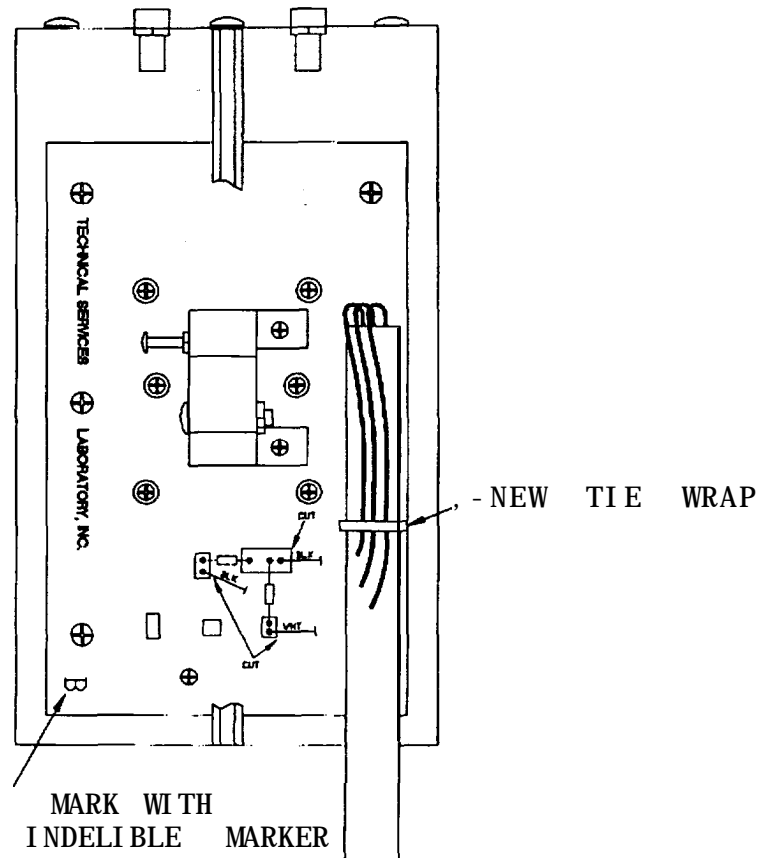
FIGURE 1

DEW POINT SENSOR ASSY
(MIRROR/CABLE SIDE)

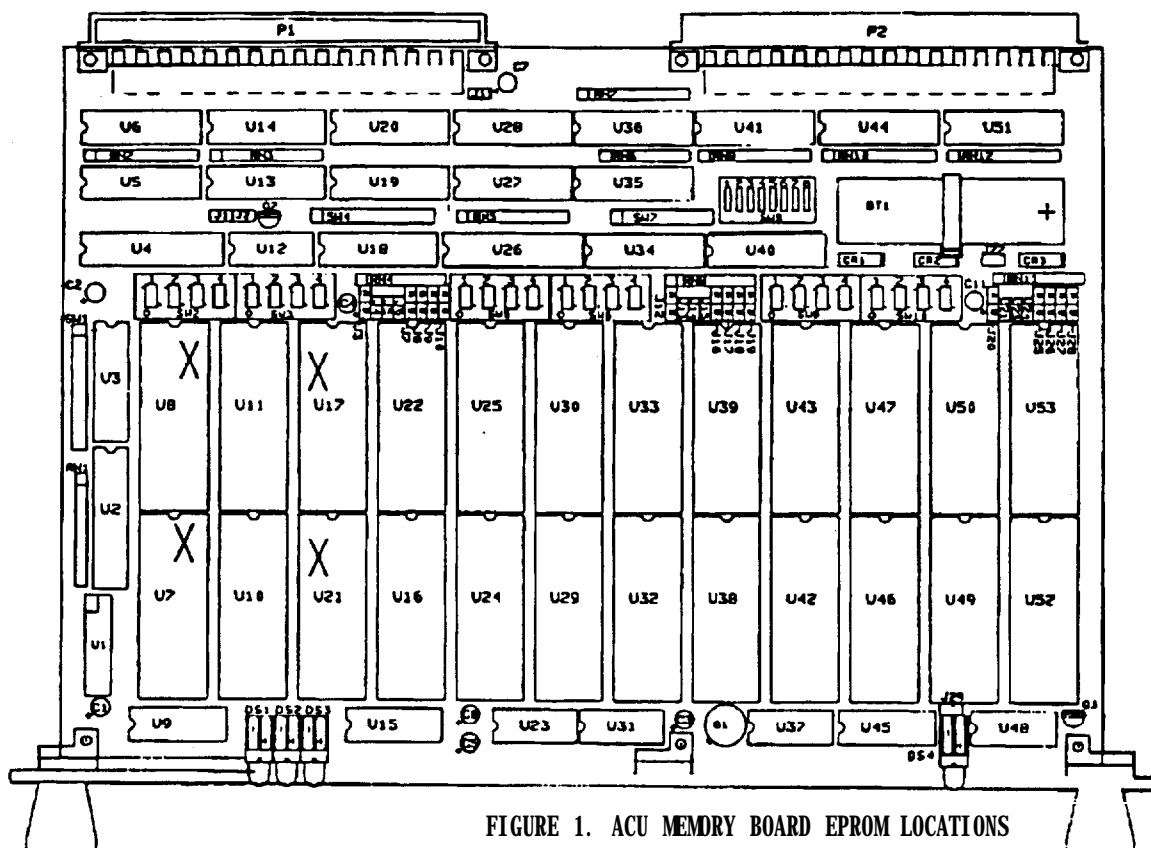
FIGURE 1. ACU MEMDRY BOARD EPROM LOCATIONS

EPROM DESIGNATOR	PART NUMBER	FUNCTION
U8	62828-45002-1	BYTE 0
U17	62828-45003-1	BYTE 1
U7	62828-45004-1	BYTE 2
U21	62828-45005-1	BYTE 3

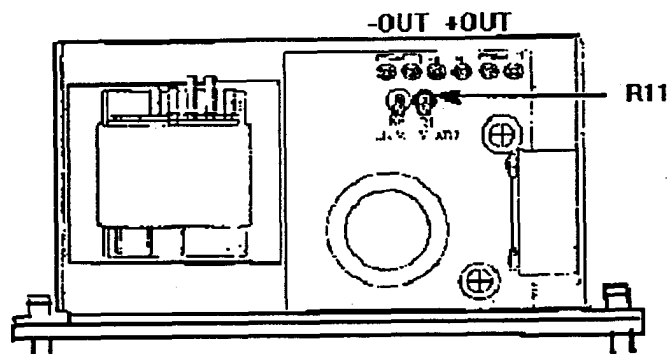
FIGURE 2

LOCATION OF ADJUSTMENT POT'S ON HEATER POWER SUPPLY FRU9

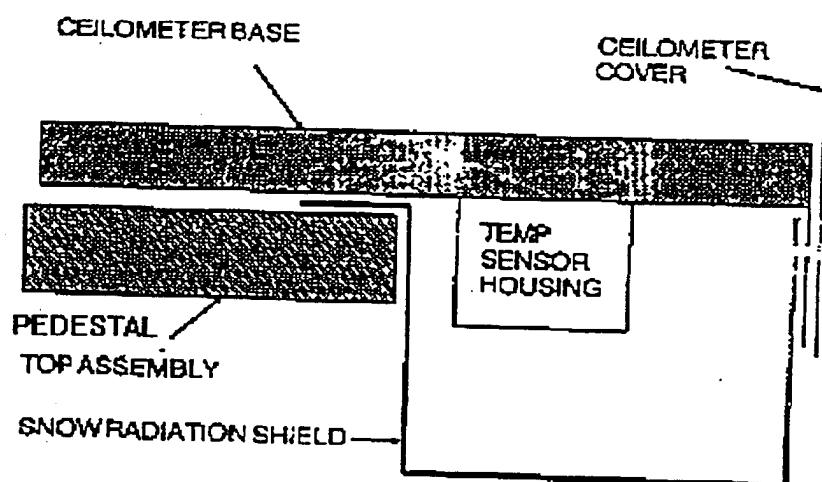
Figure 1

**CROSS SECTION OF SNOW RADIATION SHIELD
INSTALLED ON A CEILOMETER**

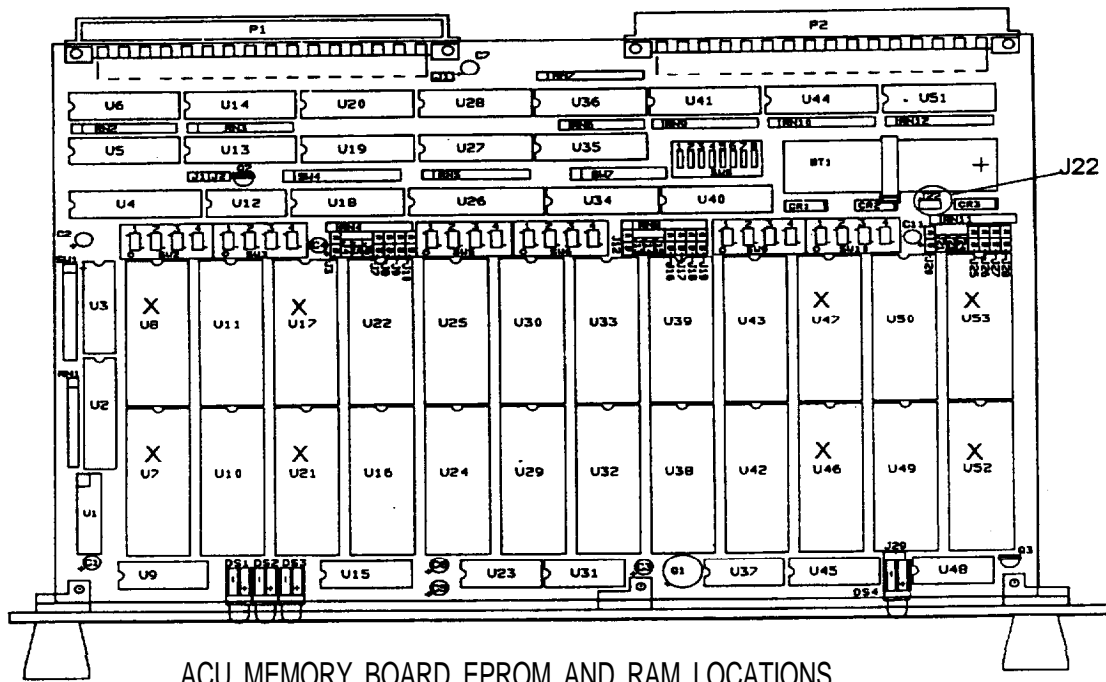
FIGURE 1

ACU MEMORY BOARD EPROM AND RAM LOCATIONS

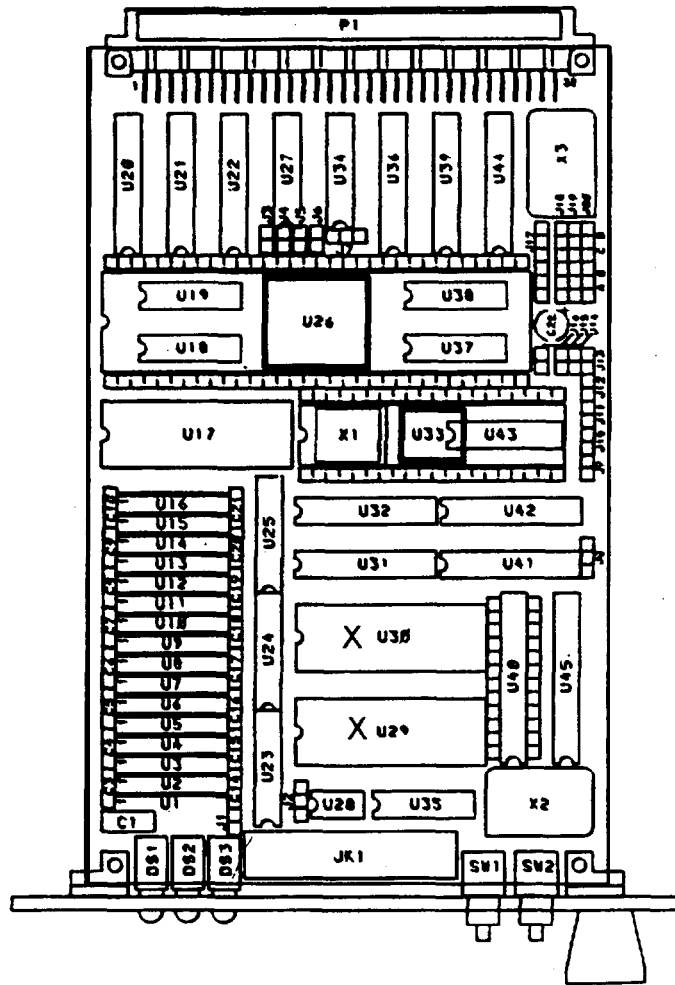
CPU BOARD

EPROM
U29
U30

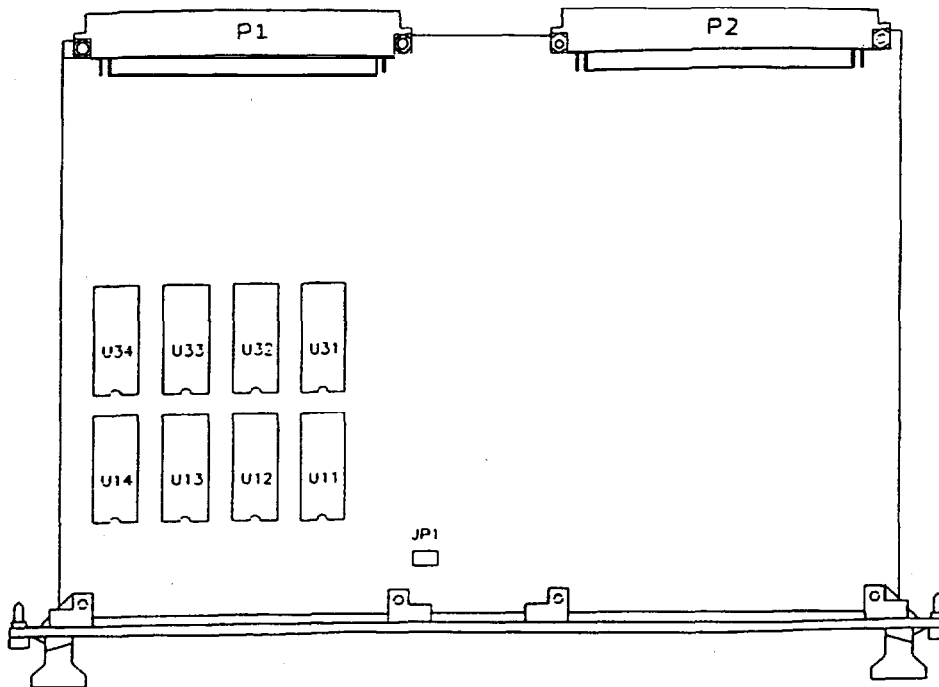
FIGURE1

VOICE PROCESSOR BOARD 1A2A20

ASSY 62828-47018-10

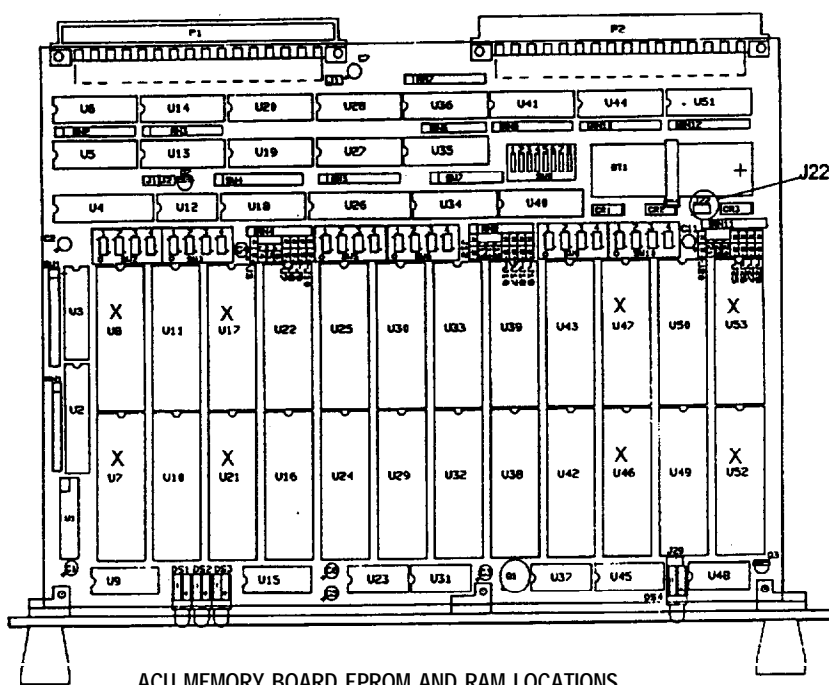
FIGURE 1

ACU MEMORY BOARD EPROM AND RAM LOCATIONS

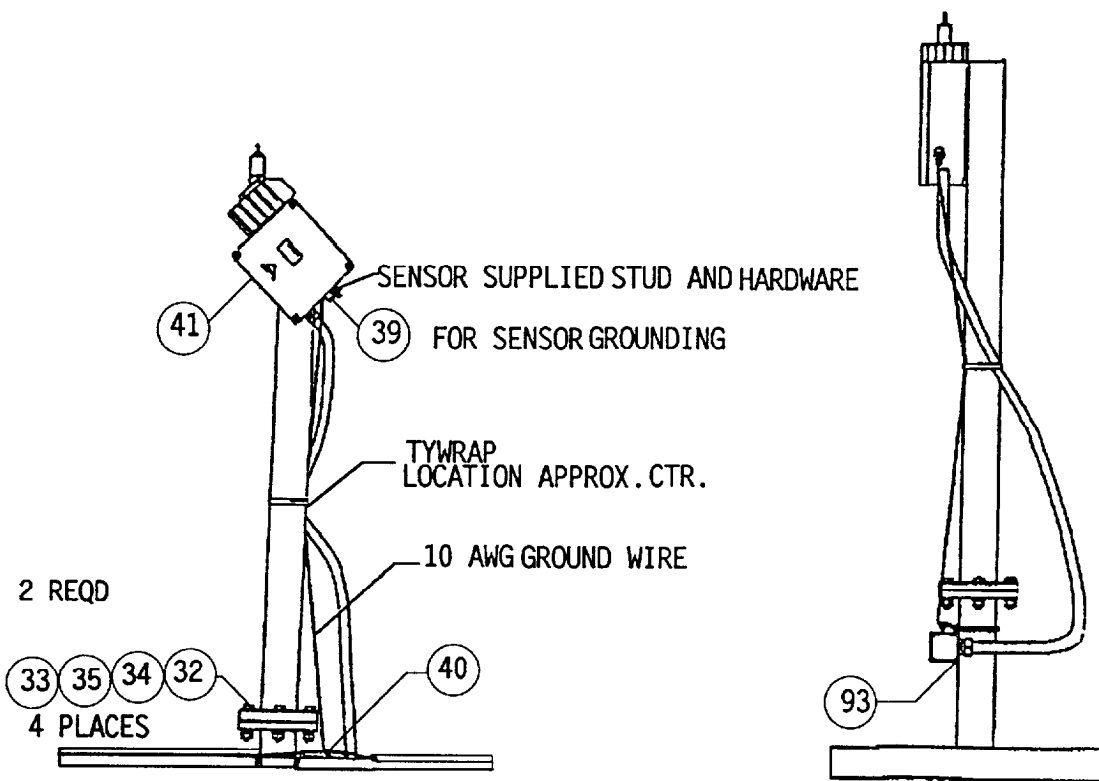
INSTALLATION DRAWING

FROM	TO	WIRE No.	COLOR
Visibility	DCP		
TB1-1	A17-9	6	BLACK
TB1-2	A18-9	6	WHITE
TB1-3	A18-9G	6	GREEN
TB1-4	A17-9	6	RED
TB1-5	A18-9	6	YELLOW
TX	RX		FIBER OPTIC CABLE
RX	TX		FIBER OPTIC CABLE
Freezing Rain	DCP		
TB1-1	A17-45		BLACK
TB1-2	A18-4	5	WHITE
TB1-3	A18-4G	5	GREEN
TB1-4	Al 7-20	5	RED
TB1-5	Al 8-20	5	YELLOW
TX	R x		FIBER OPTIC CABLE
R x	TX		FIBER OPTIC CABLE

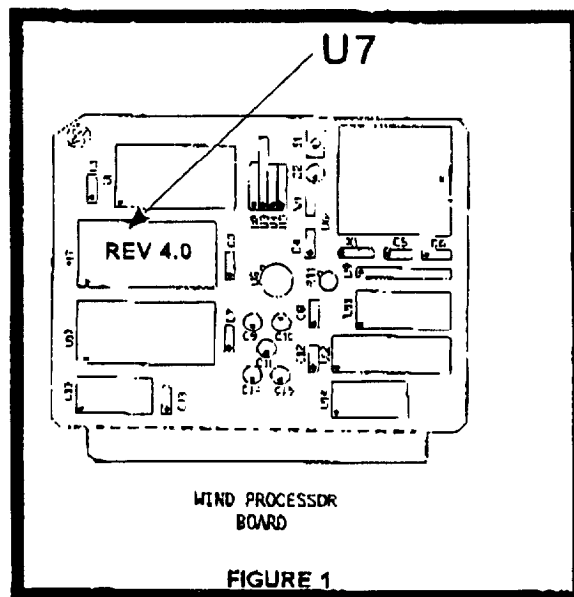
12. Locate U7 (Rev. 3.0 or earlier) on the PCB and remove from the socket using the IC Extraction tool. (Refer to figure 1).

Observe proper Pin 1 orientation and ensure EPROM legs do not become bent during the installation process.

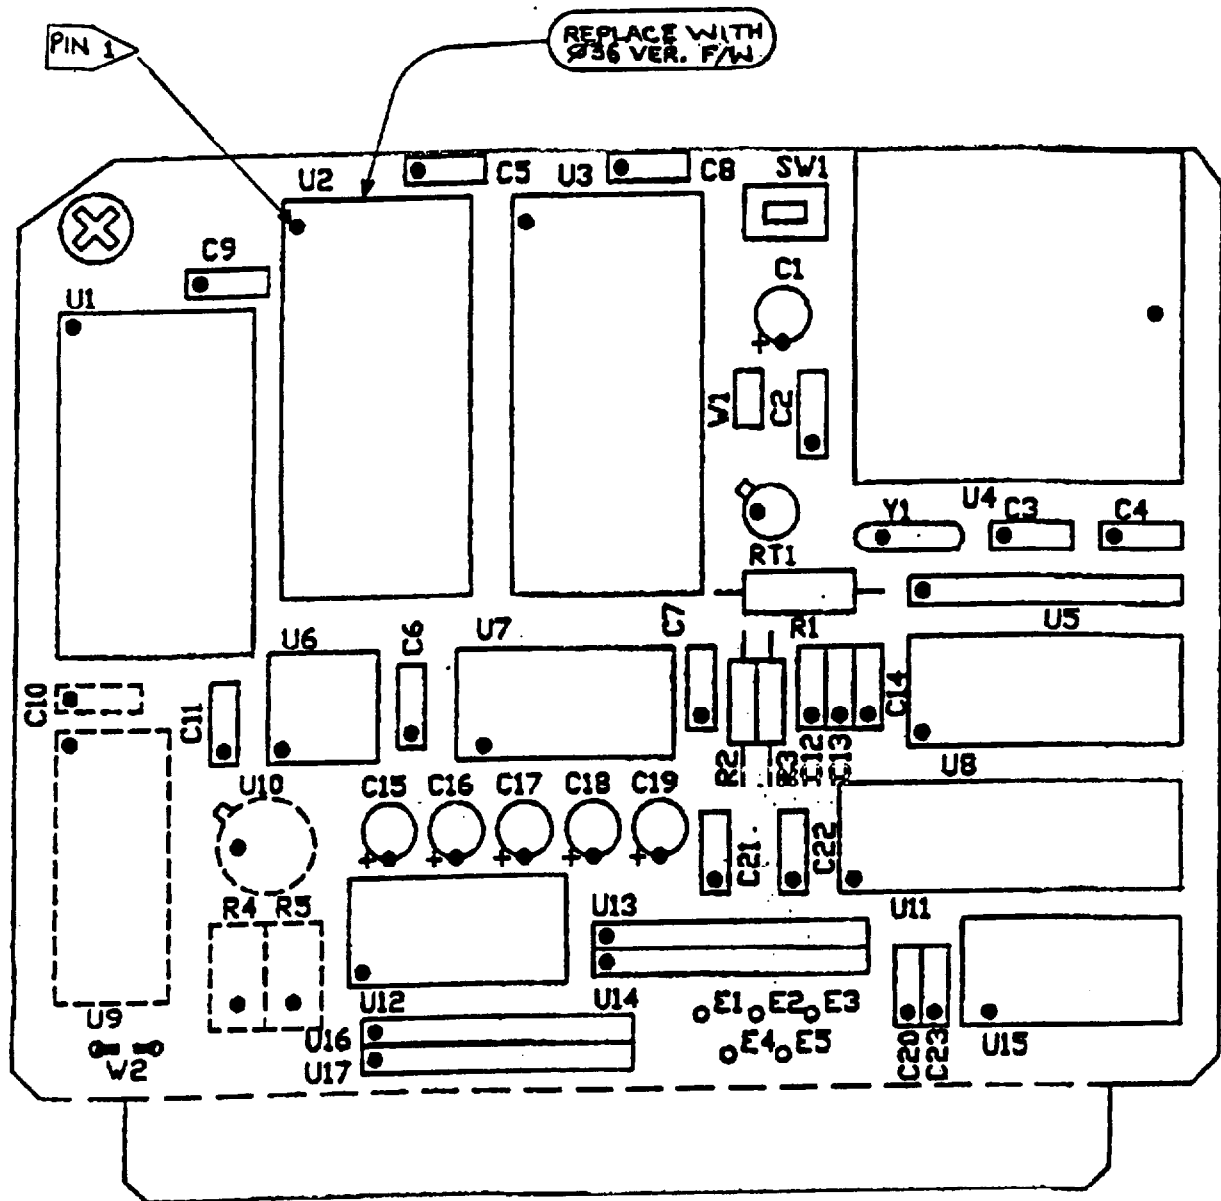
FIGURE 2

VISIBILITY PROCESSOR BOARD

P/N 32194-1

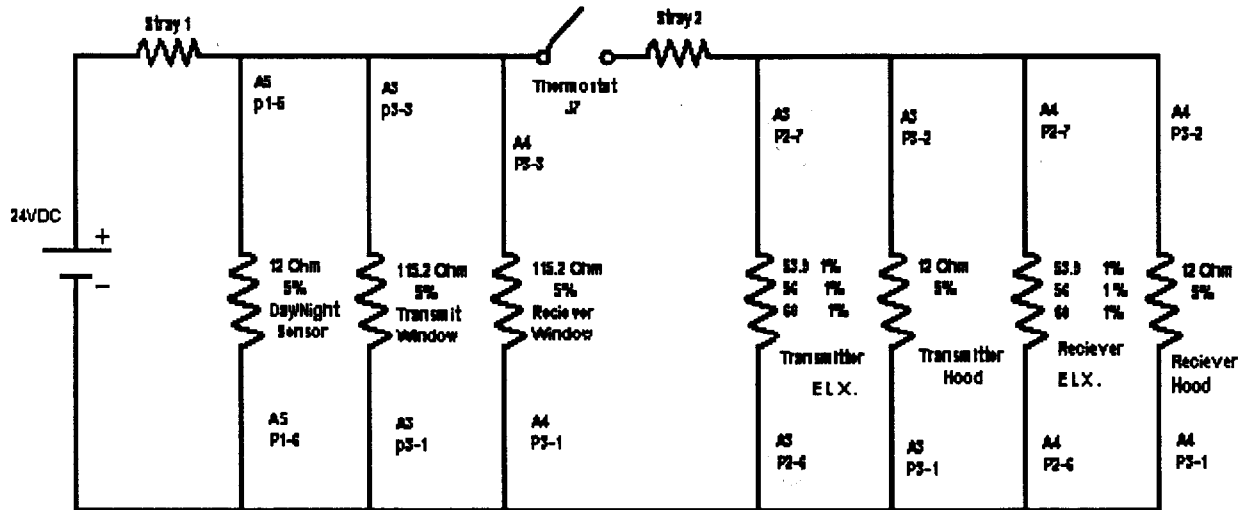
Heater Diagram
Figure 3

After following this procedure the sensor will no longer test individual sensor heaters during routine operation. Remember to place a note in the SYSLOG stating that heater diagnostics have been disabled in the Visibility Sensor. All Heaters must be checked with an Ohm meter every 90 days. Refer to the Heat Diagram (Figure 3). If Heaters fail, replace the appropriate FRU in accordance with the Site Technical Manual S-100.

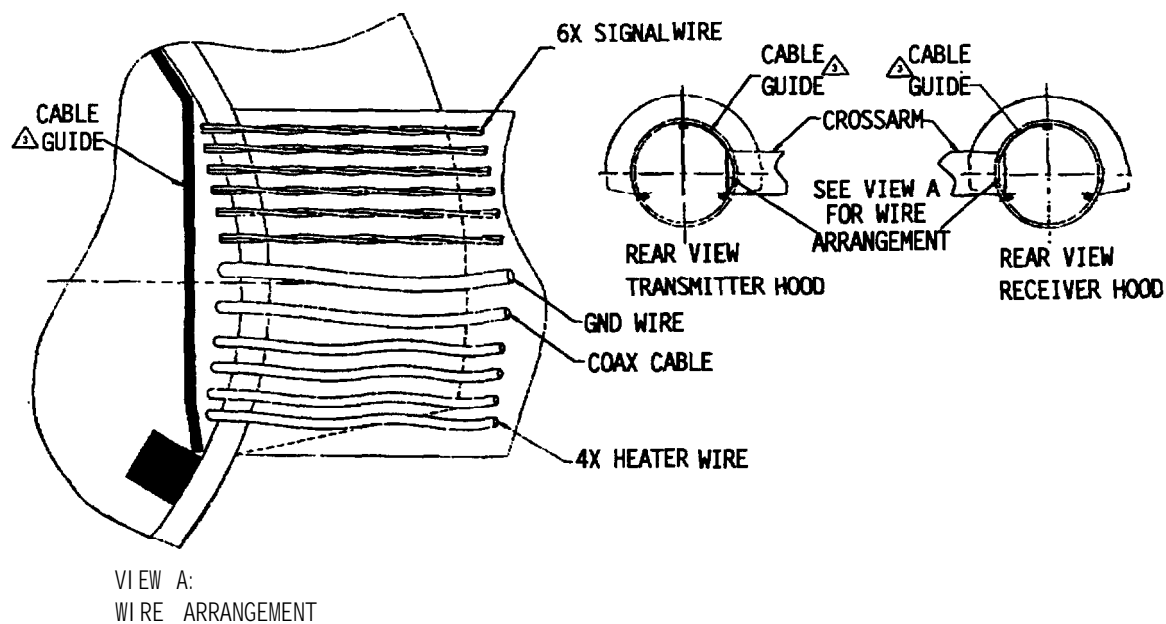
Figure 4

1. INTERPRET DRAWING PER DOD-STD. 100
2. WORKMANSHIP PER MIL-STD-45A, REQUIREMENT NO. 9
- ⚠ INSERT CABLE GUIDE AFTER THE WIRES HAVE BEEN ARRANGED IN REAR HOOD (AS SHOWN)

- b. With the tubing removed, the wire bundles can be flattened against the side of the hood. Arrange the wires so the larger heater wires, the green ground wire, and the coax cable are at the bottom as shown in the Figure 4.

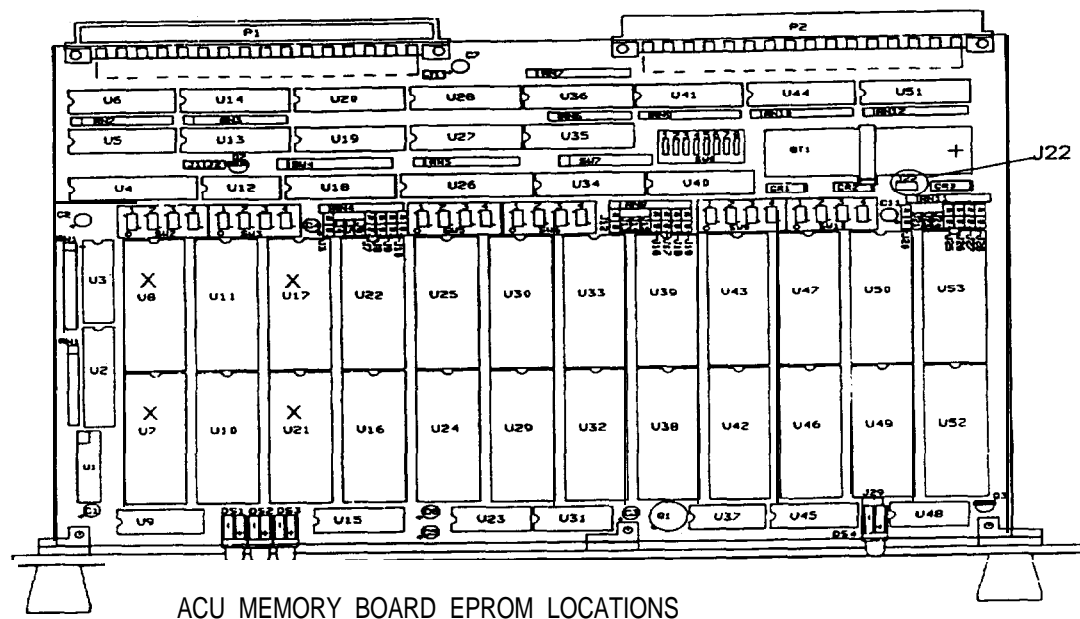
FIGURE 1

ACU MEMORY BOARD EPROM LOCATIONS

EPROM
U7
U8
U17
U21

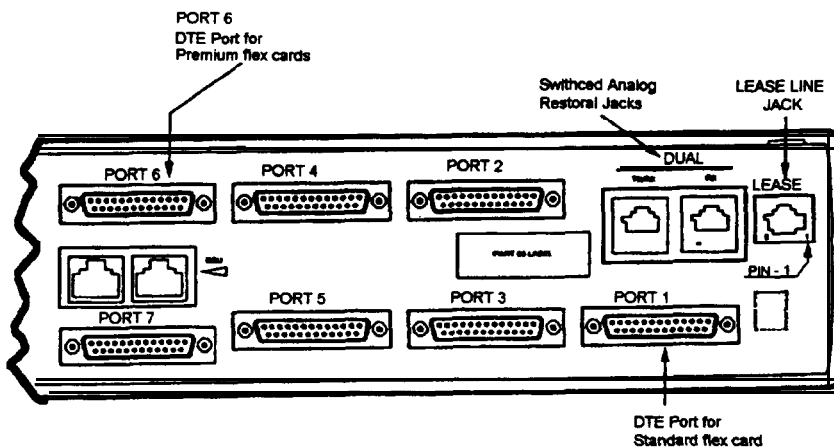
- c. Verify that a telco cable has been connected between the LEASE RJ-45 jack (reference diagram below) on the rear of the codex modem and ACU I/O panel assembly 1A9J-8 (an RJ-11 jack) via the EMI filter. Verify that this cable is wired as follows:

RJ-45 PIN	COLOR/FUNCTION	RJ-11 PIN
1	Red or Green / Transmit	2
2	Green or Red / Transmit	3
7	Yellow or Black / Receive	1
8	Black or Yellow / Receive	4
